REFERENCE: **Limited Structural Assessment**
 Dana Hills High School
 33333 Golden Lantern
 Dana Point, CA 92629
 KNA No. 371.002

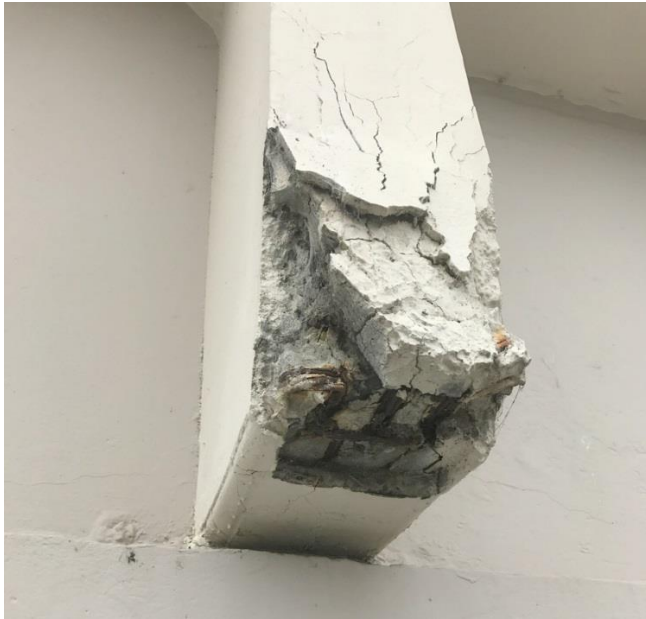
Typical tee beam tail with formed surface from original pocket visible:

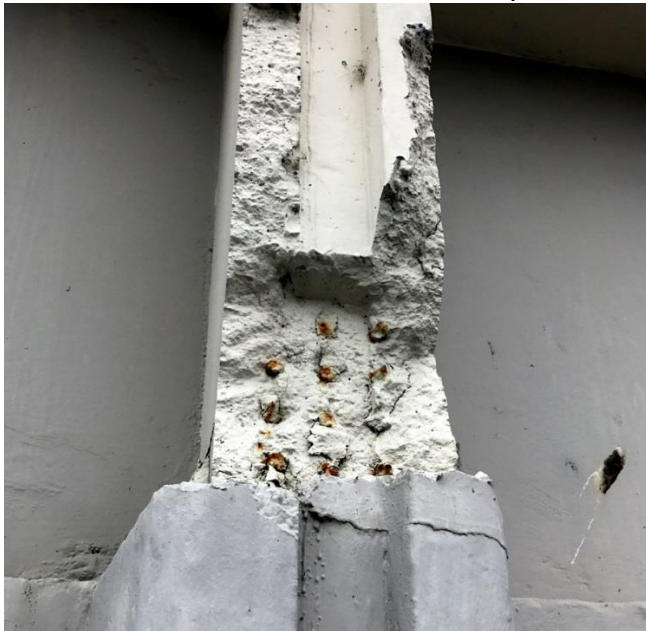
Tee beam tail with ends of tendons exposed:

We have concluded that the sand aggregate mortar mix was not a quality mix nor was it well bonded to the lightweight concrete tee beam. It did not provide proper protection for the mild steel ties or the steel pre-stressing tendons, which have corroded in the area of the cap resulting in expansive forces that have spalled the concrete. We did not note damage to any of the tee beams in the bearing area at the integral concrete beam that provides support or that the interior spans of the beams. All damage was limited to the cantilever tails at the eave of the building.

As a first step, we recommend that the district authorize us to survey the site and identify any conditions that exist where falling debris could contact students or faculty in accordance with our discussions with the Division of the State Architect's San Diego office. We recommend the district provide barricades limiting path of travel in those areas until repairs are made. As a second step, we recommend that the district authorize us to perform a thorough survey of all tee beam ends on site and that we prepare a plan identifying every beam in need of repair details and specifications for the proper repair of the affected tee beams.

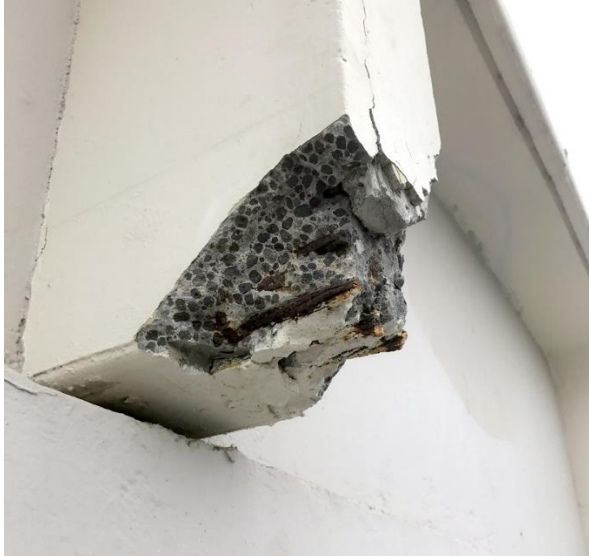
Lightweight aggregate and sand aggregate mortar visible (note ledge of integral beam that provides vertical bearing support for the tee beams):

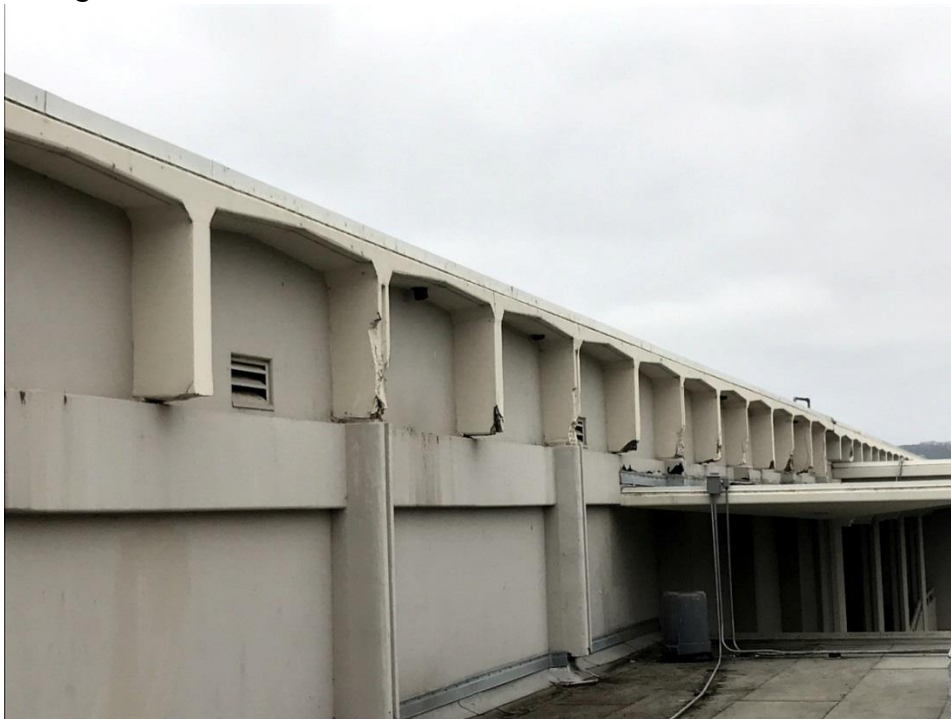
Overall picture of tee beam ends showing integral beam that provides bearing support and all damage limited to the cantilever tails:

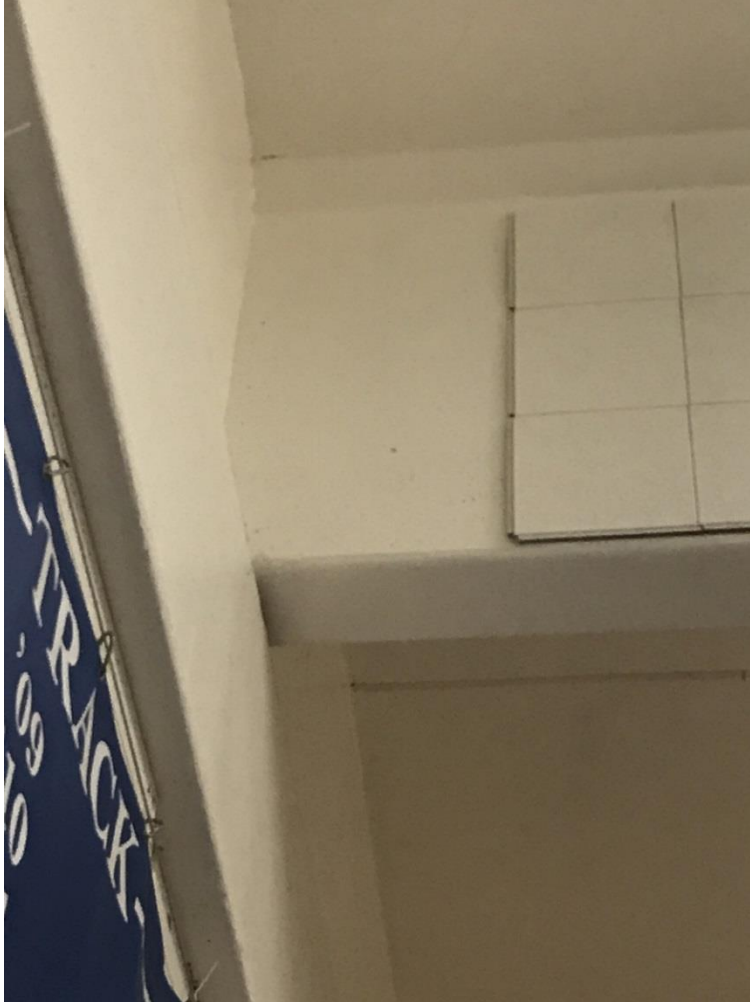
Interior span of the tee beams exhibited no signs of distress:
