REFERENCE: **Falling Debris Hazard Mitigation Recommendation**
 Dana Hills High School
 33333 Golden Lantern
 Dana Point, CA 92629
 KNA No. 371.002

This report presents our findings of our assessment and recommendations for the mitigation of the potential for falling debris on students or staff at the aforementioned site as a follow up to our report dated September 28, 2017 as it relates to our initial structural assessment at the Gymnasium and the Shower and Locker Buildings located at Dana Hills High School.

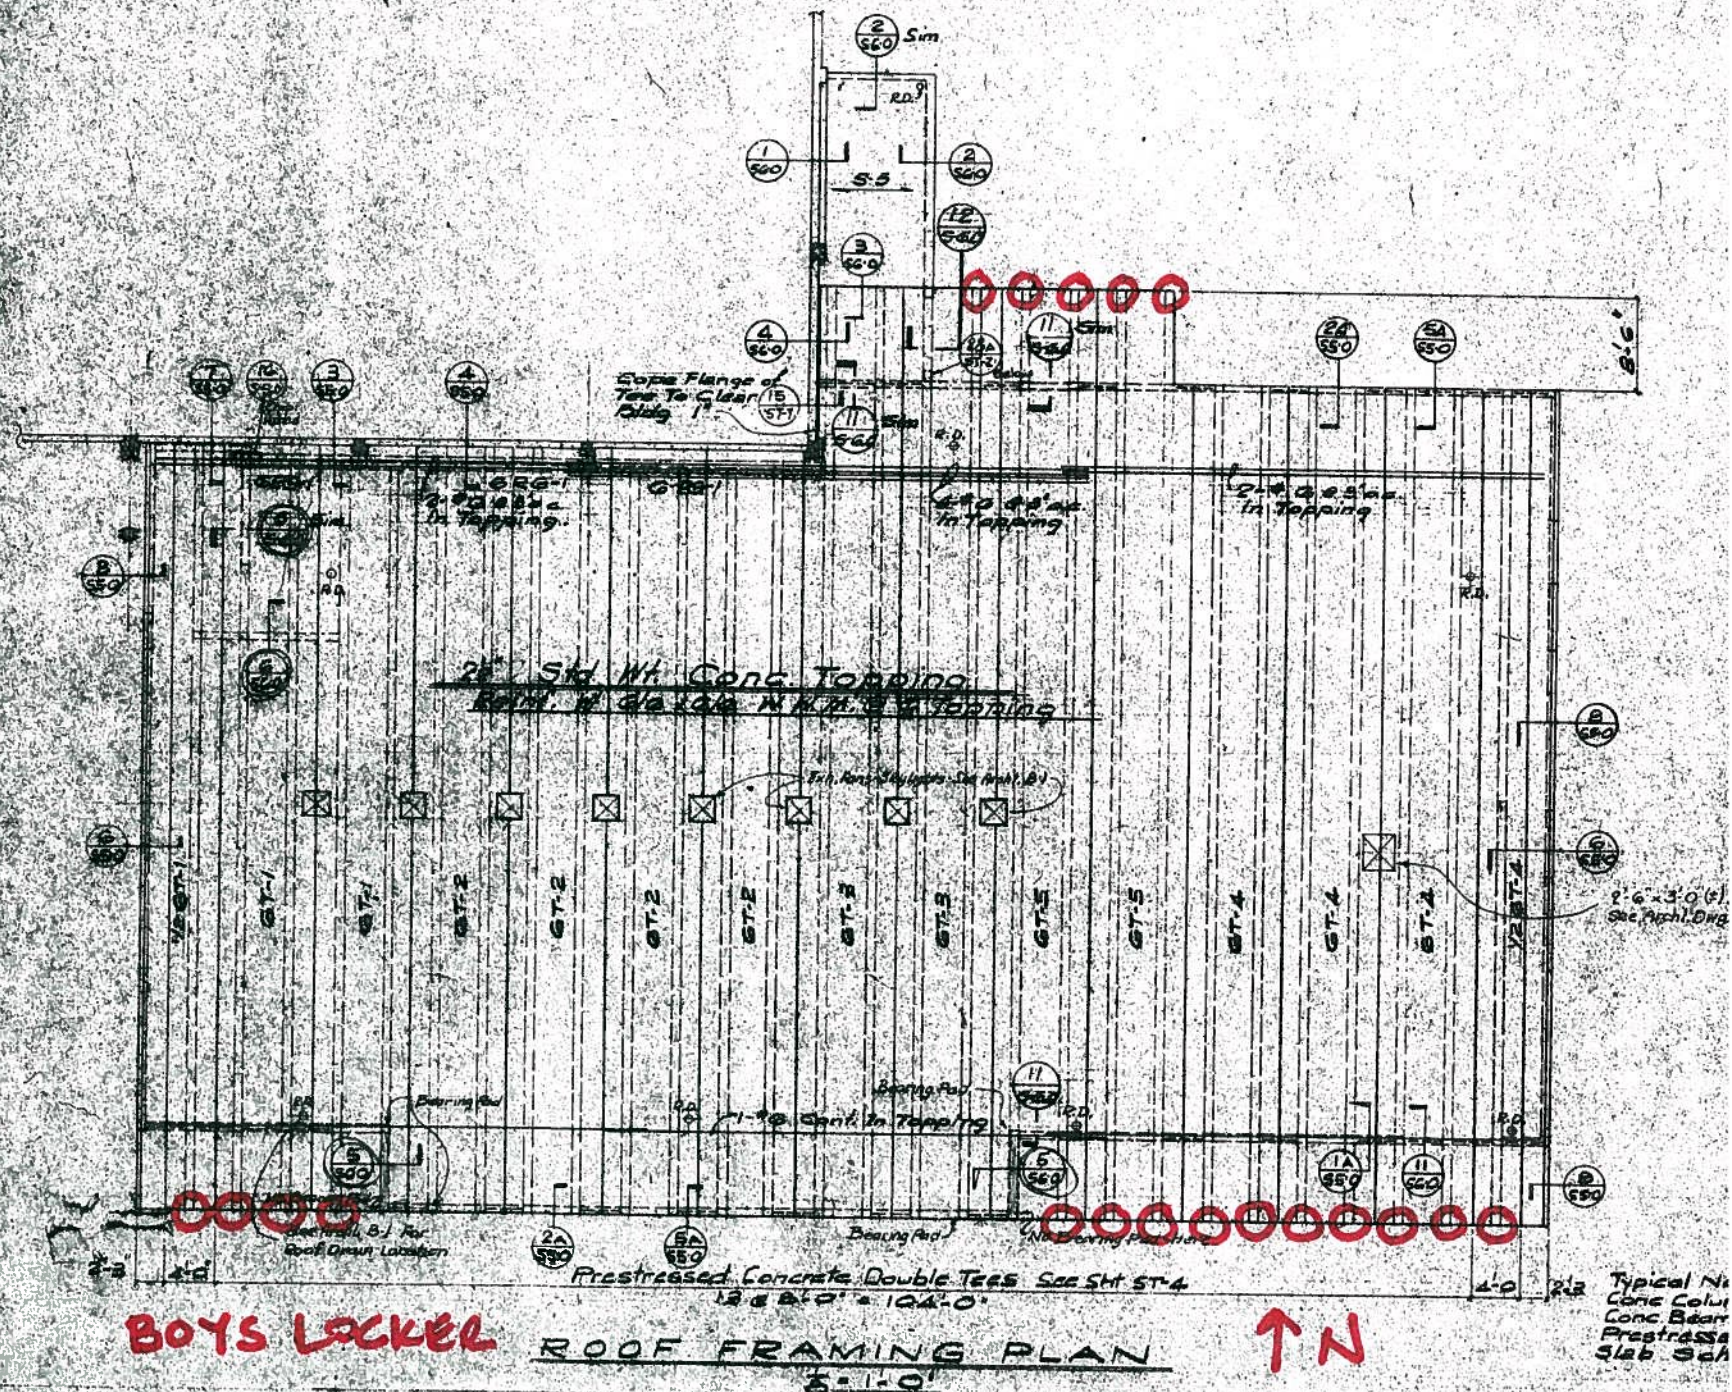
ROOF FRAMING PLAN
5'-1'-0"

The tee beam ends for the roofs over the Gymnasium, Student Mall, and Theater all occur over adjacent low roofs. Consequently the current state of deterioration does not pose any threat of falling debris on students and staff from the tee beam ends in those areas. The tee beam ends for the roofs over the Boys' and Girls' Shower and Locker areas occur over exits, walkways and path of travel. We have identified areas on the attached markup of the existing structural roof framing plans where beam ends pose a threat of falling debris on students and staff. Areas of concern are circled in red.

We recommend that the loose material at the ends of all tee beams identified on the attached plans be knocked off by mechanical means such that only sound material remains. This is the most straightforward and full proof approach to protecting students and staff from the risks of falling debris.
