September 11, 2017

REFERENCE: **Limited Structural Assessment**
 Dana Hills High School
 33333 Golden Lantern
 Dana Point, CA 92629
 KNA No. 371.002

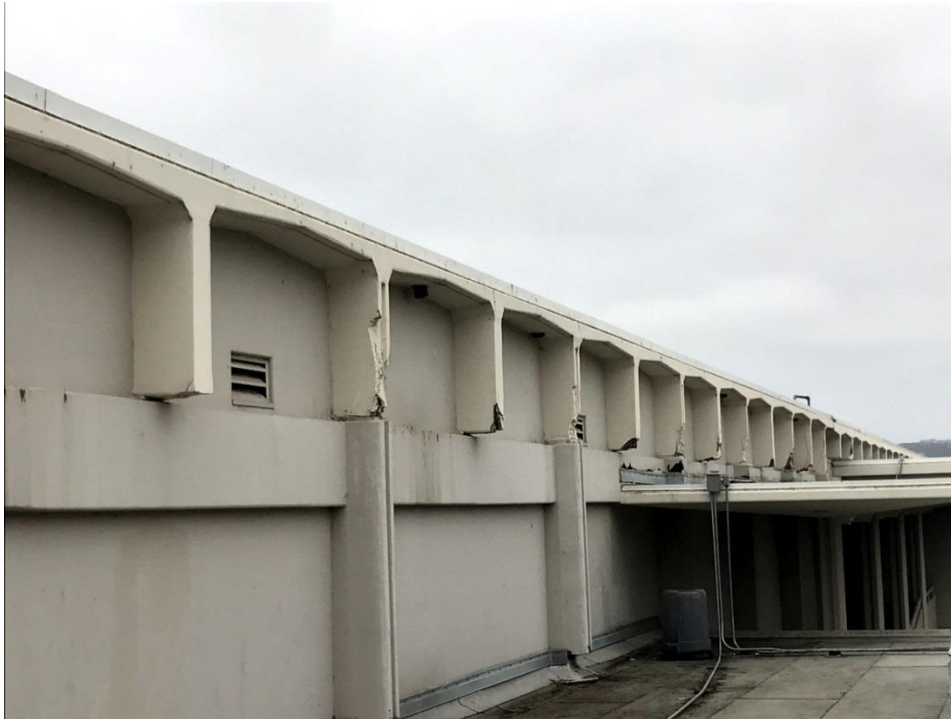
Overall picture of tee beam ends showing integral beam that provides bearing support and all damage limited to the cantilever tails:

We have concluded that the sand aggregate mortar mix was not a quality mix nor was it well bonded to the lightweight concrete tee beam. It did not provide proper protection for the mild steel ties or the steel pre-stressing tendons, which have corroded in the area of the cap resulting in expansive forces that have spalled the concrete. We did not note damage to any of the tee beams in the bearing area at the integral concrete beam that provides support or that the interior spans of the beams. All damage was limited to the cantilever tails at the eave of the building.

As a first step, we recommend that the district authorize us to survey the site and identify any conditions that exist where falling debris could contact students or faculty in accordance with our discussions with the Division of the State Architect's San Diego office. We recommend the district provide barricades limiting path of travel in those areas until repairs are made. As a second step, we recommend that the district authorize us to perform a thorough survey of all tee beam ends on site and that we prepare a plan identifying every beam in need of repair details and specifications for the proper repair of the affected tee beams.
