Limited Asbestos Assessment

Newhart Middle School

25001 Veterans Way, Building 300, Southeast and Northwest Roofs

Project Number: Atch-230586

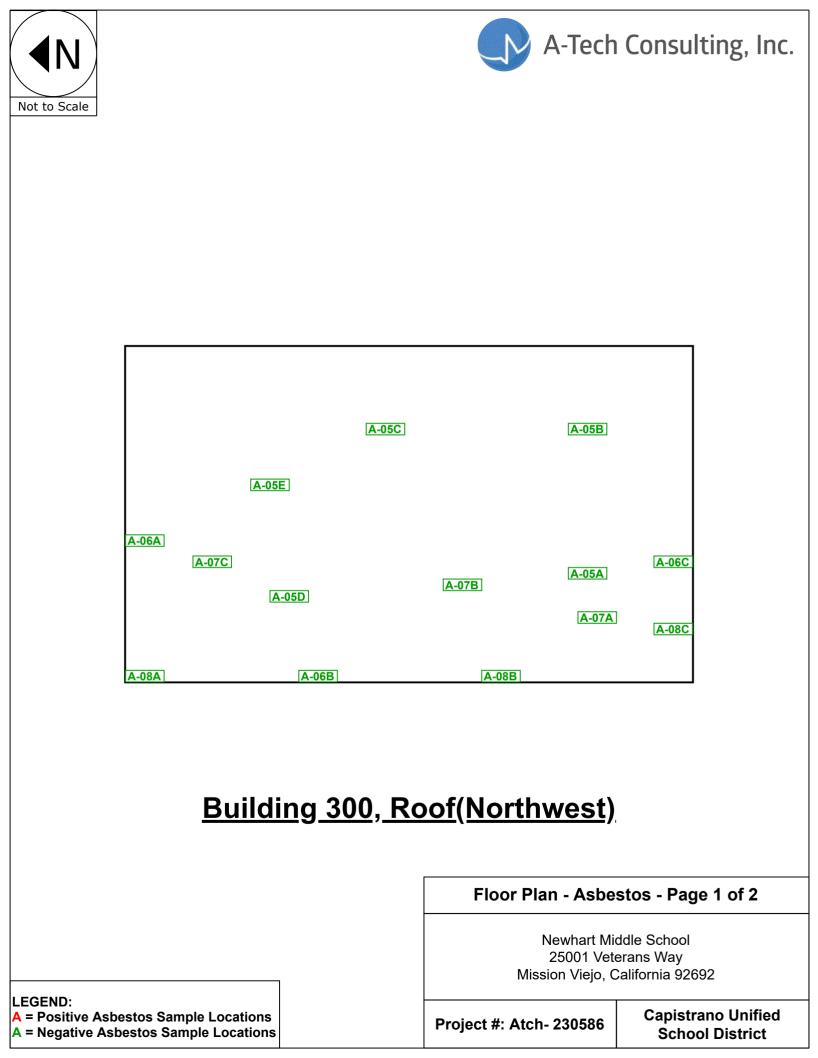
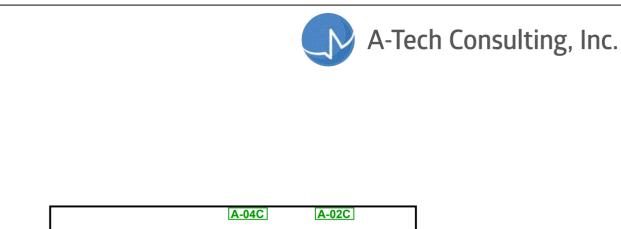
Floor Plan - Asbestos - Page 2 of 2

Building 300, Roof(Southeast)
