LIMITED ASBESTOS & XRF-LEAD ASSESSMENT

R.H. Dana Elementary School

24242 La Cresta Drive, Roofs

Project Number: Atch-220235

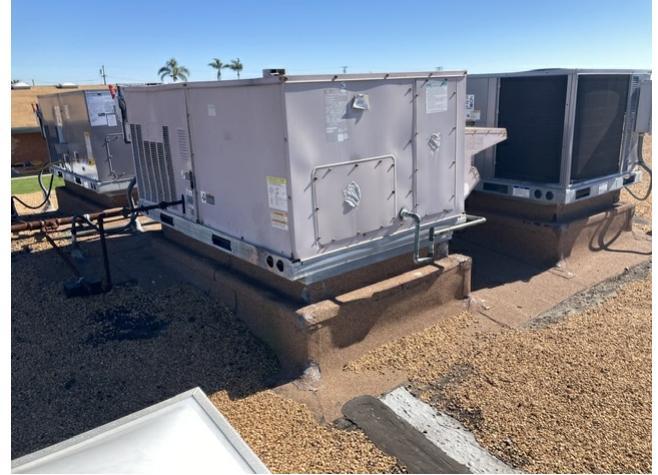
View of Asphalt Rolled Roofing with Mastic (HVAC Mounts and Penetrations) on Building 1, Roof

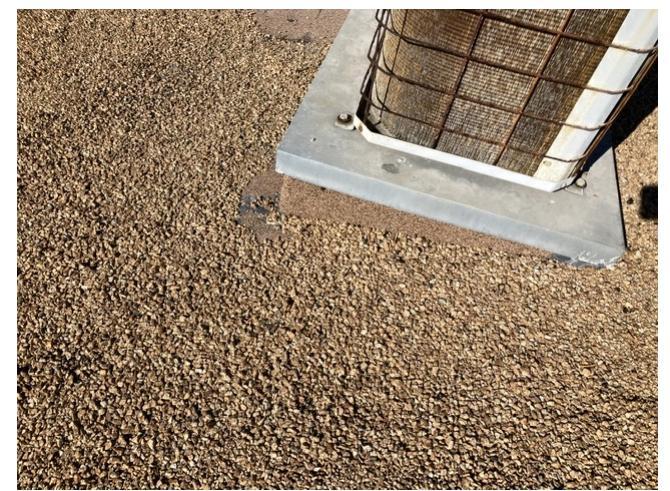
View of Asphalt Rolled Roofing with Mastic (HVAC Mounts and Penetrations) on Building 2, Roof and Building 4, Roof

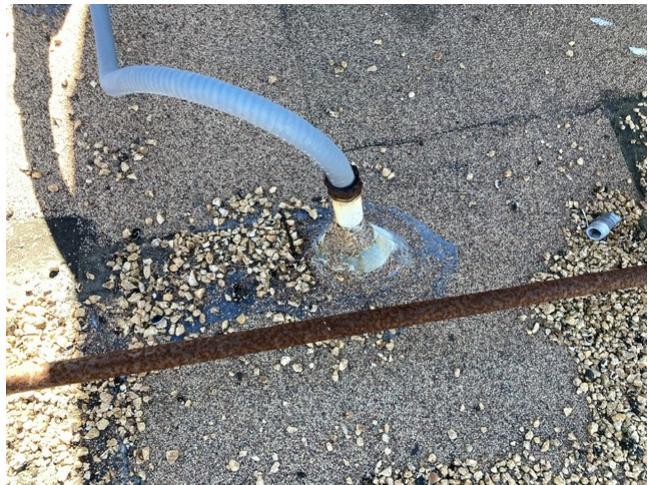
View of Penetration Mastic on Building 1, Roof

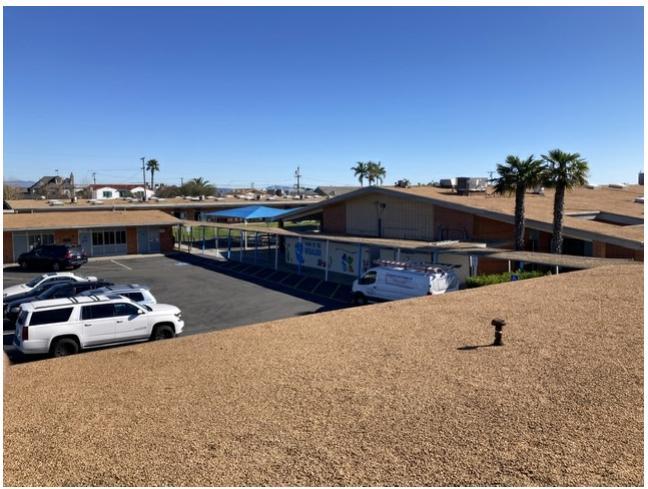
View of Flashing/Penetration Mastic on Building 2, Roof

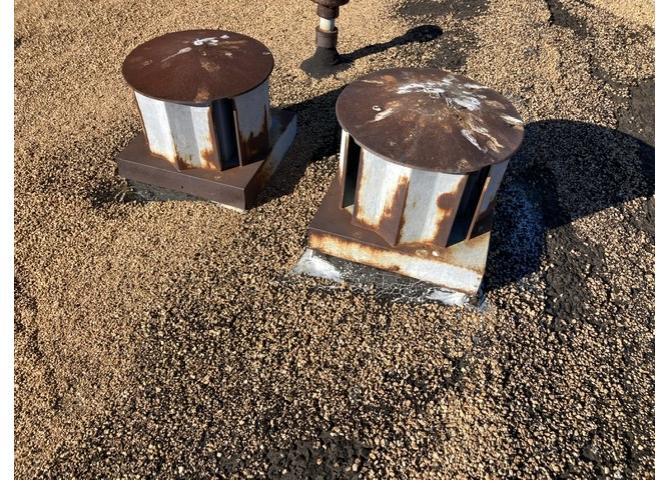
View of Flashing/Penetration Mastic on Building 3, Roof

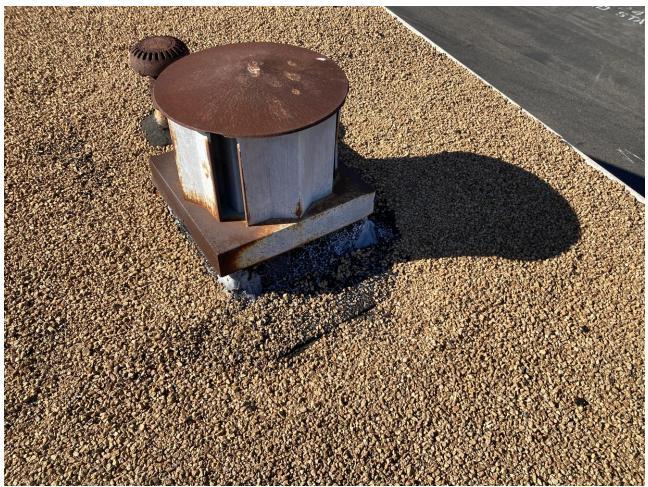
View of Flashing/Penetration Mastic on Building 4, Roof

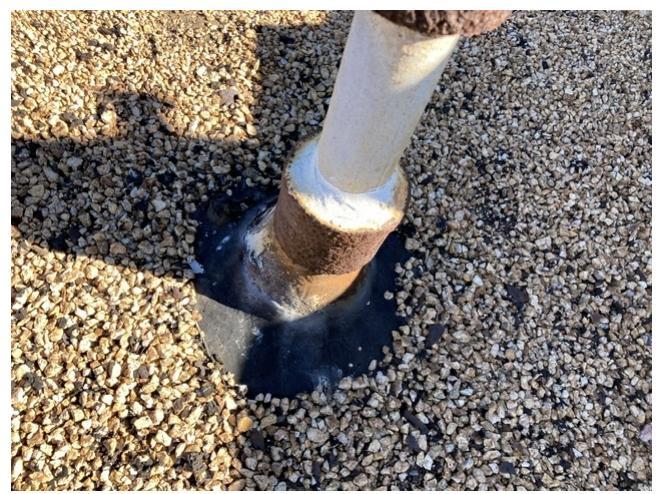
View of Flashing/Penetration Mastic on Building 5, Roof
